Dry-dock report

Vessel: ASTRA

IMO: 8878192

Shipyard: Kållandsö Varv

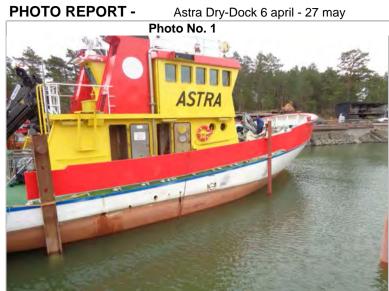
Indocking.

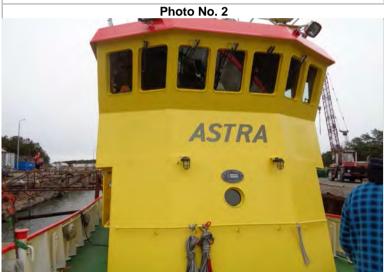
Indocking.

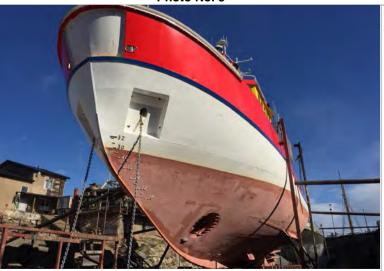
Condition of exterior hull after HP wash.

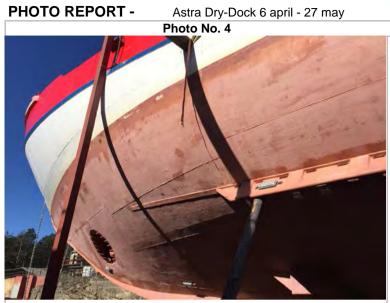
Condition of exterior hull after HP wash.

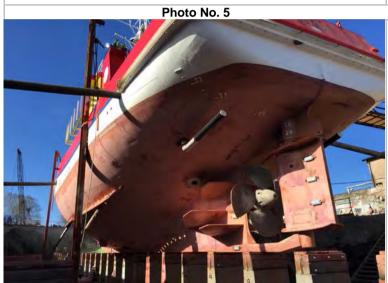
Condition of exterior hull after HP wash.

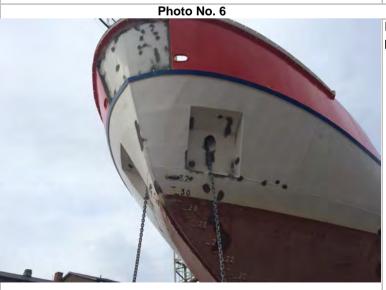
Example of surface preparation spotbalsting.

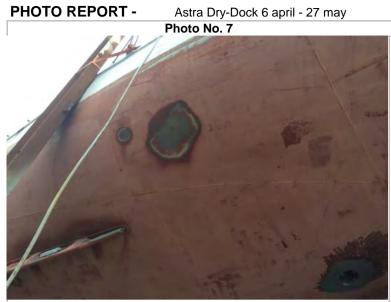
Example of surface preparation spotbalsting.

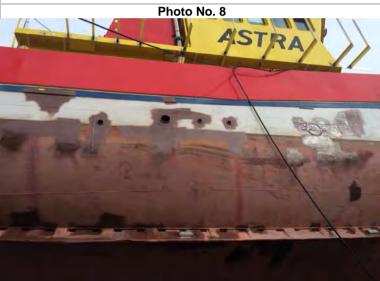
Exampel of first T/U exterior hull.

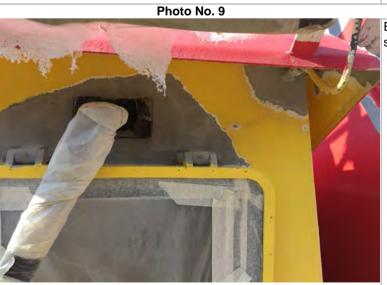
Exampel of spotblasting superstructure.

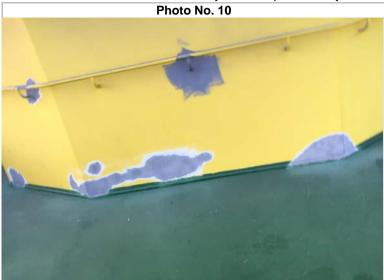
Exampel of spotblasting superstructure.

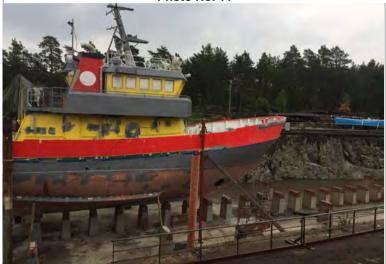
Paintwork in progress.

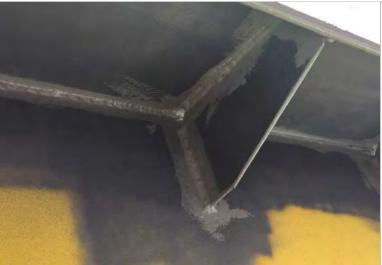
Exampel of touch up areas followed by stripe coat.

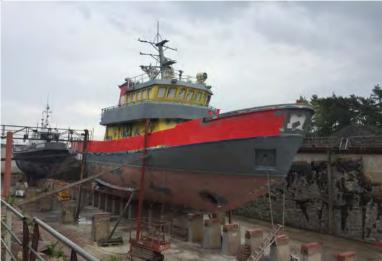
Paintwork in progress overview.

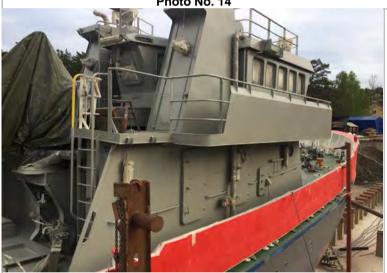
Photo No. 15

Superstructure paintwork in progress.

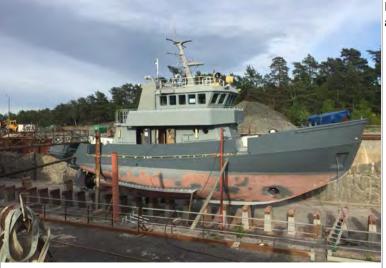
Final full coat at topsides and superstructure.

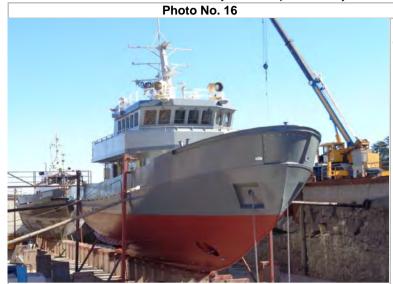
Full coat of antifouling compleated.

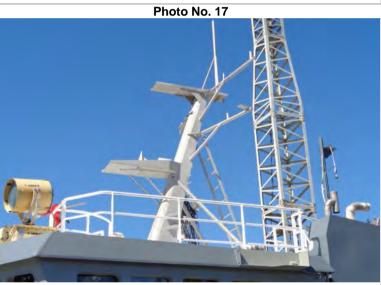
Mast blasting and painting compleated. Mast only mineralbased blasted.

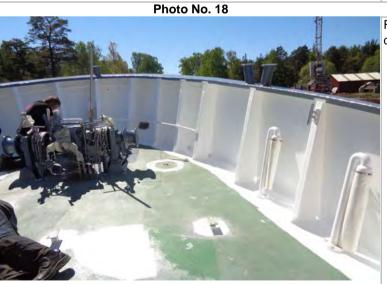
Final full coat of exterior decks and bulwark interior.

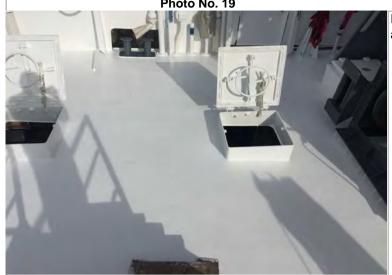
Final full coatexterior deck aft completed.

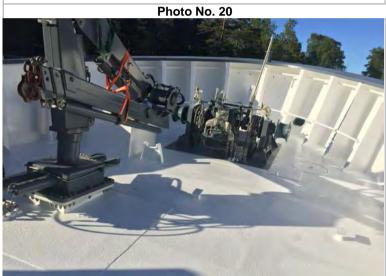
Final full coat exterior deck forward completed.

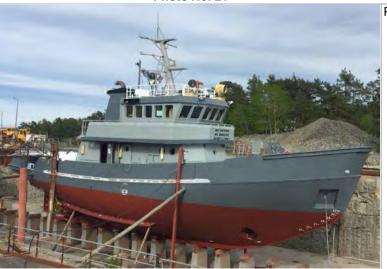
Paintwork completed.
